Electronic Parts and Electrostatic Discharge (ESD) – Gaps and Mitigation Strategies

Shri G. Agarwal

NASA – Jet Propulsion Laboratory, California Institute of Technology Shri.g.agarwal@nasa.gov 818-354-5598

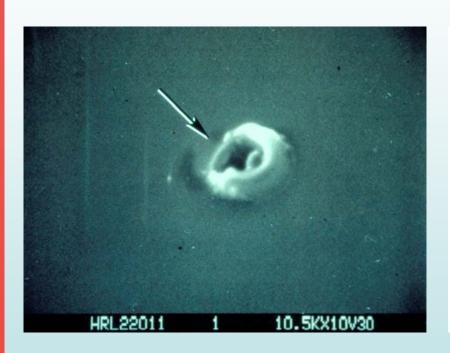
Arrow indicates rupture in thin oxide of large area MOS capacitor. Overlying metallization removed.

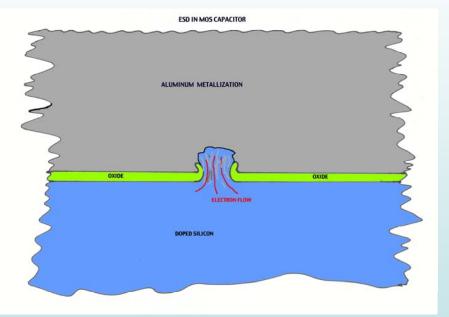
Note relative thickness of overlying metal scaled to size of defect. There would be no obvious damage to the metal visible on the surface.
